**Contract No:** 306-C-00-11-00506-00  
**USAID Project Title:** Kandahar Helmand Power Project (KHPP)  
**Document Title:** Assessment Report  
Kajaki Dam Unit 2 Hydro Inventory and Condition  
**Author(s):** John (Jack) Whippen  
**Contractor:** Black & Veatch Special Projects Corp.  
**USAID Agency:** USAID Office of Infrastructure, Energy, and  
Engineering - Afghanistan  
COR: Massoud Orya  
**Date of Publication:** February 5, 2014  
**Language:** English

## **Kandahar Helmand Power Project (KHPP)**

Kajaki Dam Unit 2 Hydro Inventory and Condition  
Assessment Report – FINAL  
January 31, 2012

**AMENDED 5 FEBRUARY 2014**

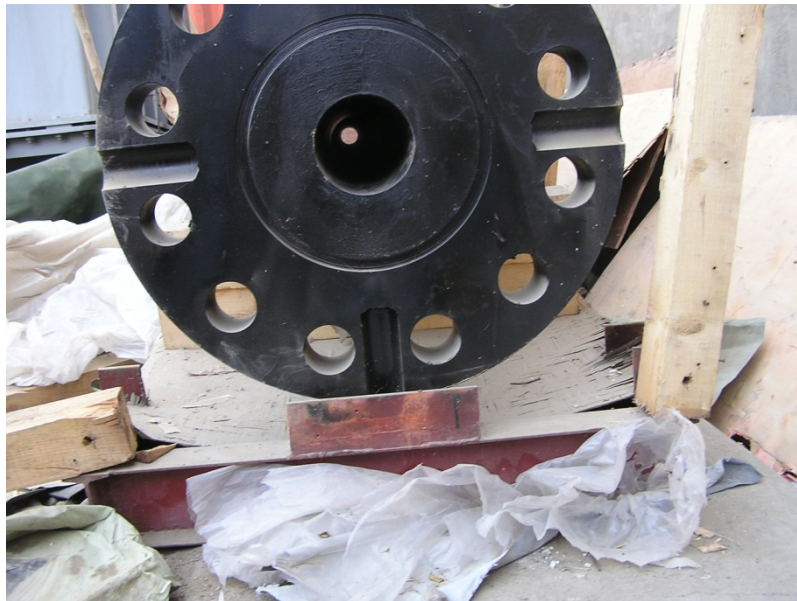
End of Generator Shaft showing rounded keyways.

The full shaft is painted with a thin black film, probably to be removed upon installation. The lower bearing journal is painted with a red paint. Since most of the damage seemed to be to the crate packing, and no paint damage was noted on the shaft, it is anticipated that there is no concern about use of this shaft.

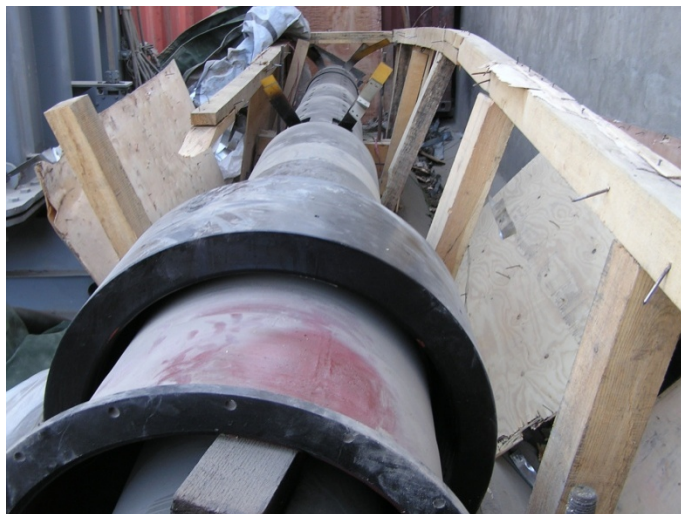
Lower Guide Bearing journal stove pipe.

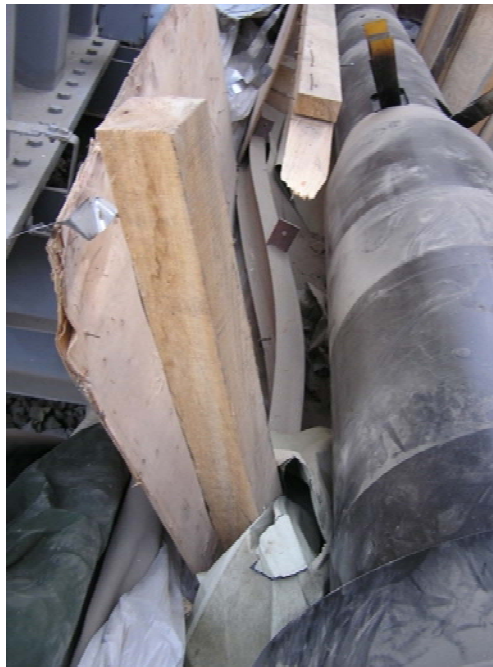
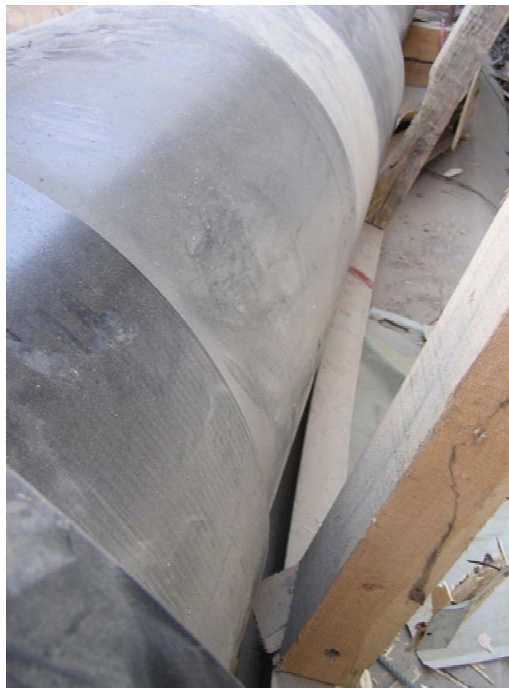
The following two photos show the damage to the support beams for the crate. It should be possible to reuse this arrangement to transport to the plant but one or two additional saddles should be installed on the central portion of the shaft. At the time of saddle installation, with a crane lifting one end, further inspection may be obtained of the covered portion of the shaft. If it is determined that the existing saddles require further support, or additional lateral support is needed at the bottom of the crate, that should be added at that time.

Damaged lateral support beams at the largest shaft diameter.

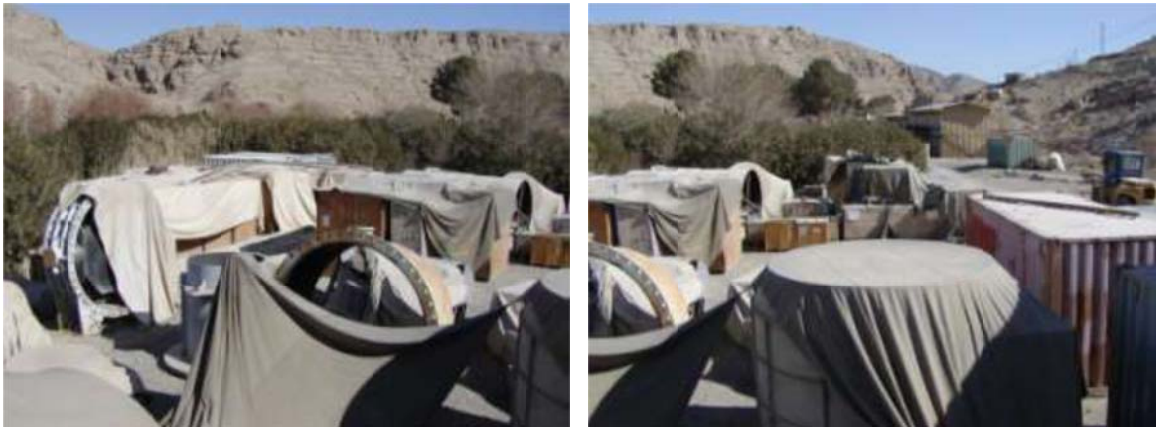
The “at large” material had been placed in sequence with no room to maneuver a forklift or other material handling equipment between the items. In many instances, large rocks were used for cribbing under the crates apparently due to the lack of timber on site for cribbing.

Typical “at large” storage of crated and uncrated apparatus

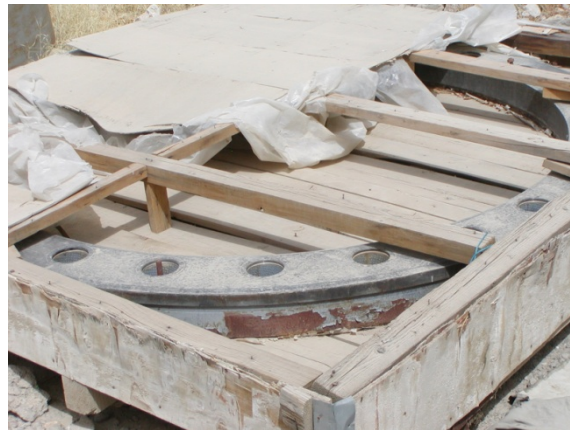
Lower Ring showing paint deterioration

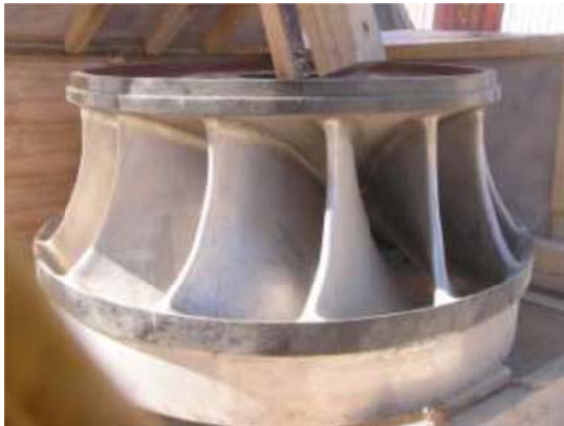
The runner is a martensitic stainless steel and has some minor areas of corrosion present. There are notations for matching the turbine shaft to the runner. A new turbine shaft was supplied with the new generator shaft. The runner/turbine shaft match is fixed with flat keys at 90°.

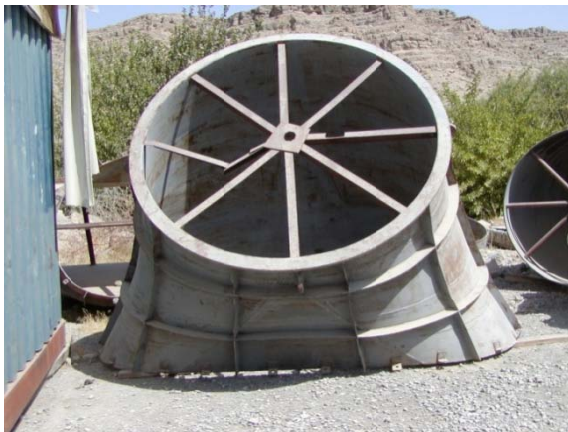
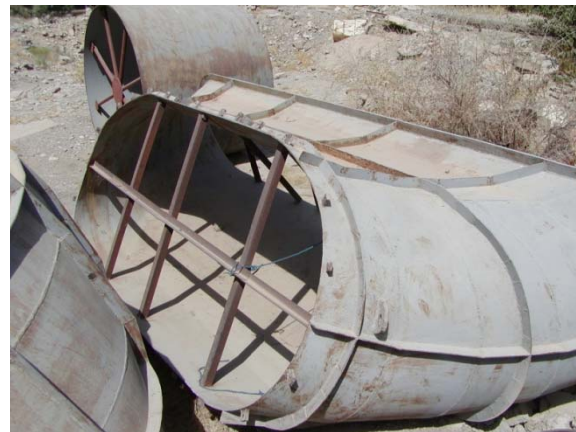
Draft Tube Sections

The edges for welding were in good shape with a partial “Vee” shape provided. The flanges are well sized. Supports to maintain shape during shipment were sturdy and well placed. The paint coating has deteriorated.

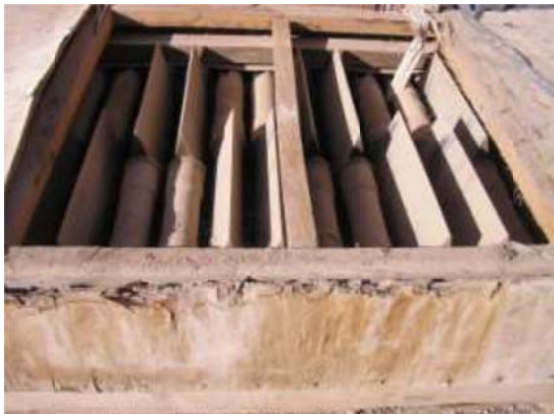
Twenty-four guide vanes (wicket gates) are provided. The shipping crate was badly deteriorated but the guide vanes are in satisfactory condition. The combination of 24 guide vanes and 14 runner blades is unusual due to the potential for penstock resonance vibration, but may not be a problem in this application.

Guide Vanes (Wicket Gates), 24 count

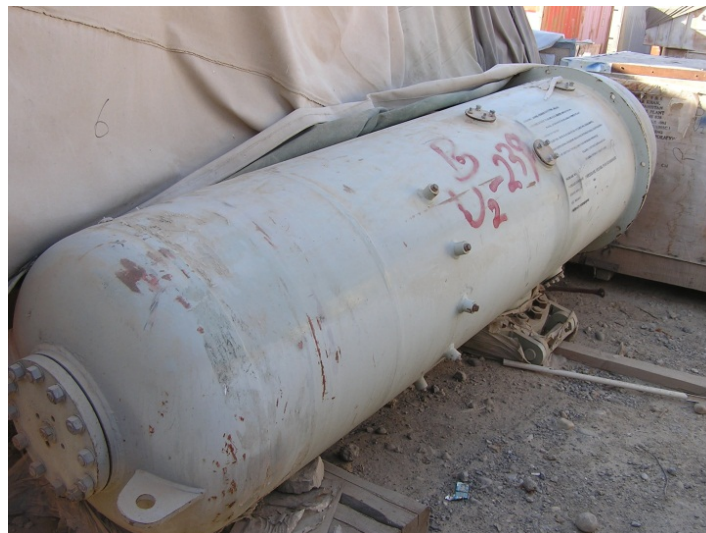
There is no stamp or other evidence of tank certification for the governor oil cushion tank. The tank should be certified for service. The tank has been exposed to the elements and has deteriorated and will need to be repainted before being placed in service.

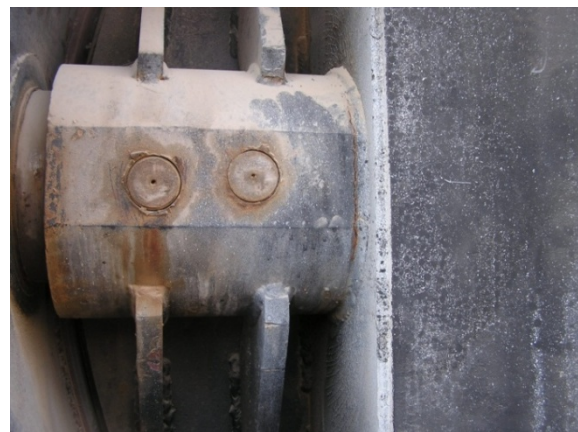
Both of the cylinders welded to the gussets have cracks adjacent to the stiffener plate. These are not critical structural connections and can be repaired on site. Cracking was probably due to excess heat applied during construction welding with no provision for thermal contraction during cooling. A field repair should incorporate grinding a “Vee” for the length of the crack and two short weld passes for that length with cooling between passes. Cover passes should duplicate that process until the groove is filled. Emphasis should be on penetration into the cylinder rather than the side gusset plate. The additional ties to the leaf are sufficient to provide support to what is essentially a spacer on the leaf shaft. Cracking was found on both sides as well as the back side of the cylinder shown on the left side. The back side cracking is not accessible for repair.

Close-up of left cylinder with crack

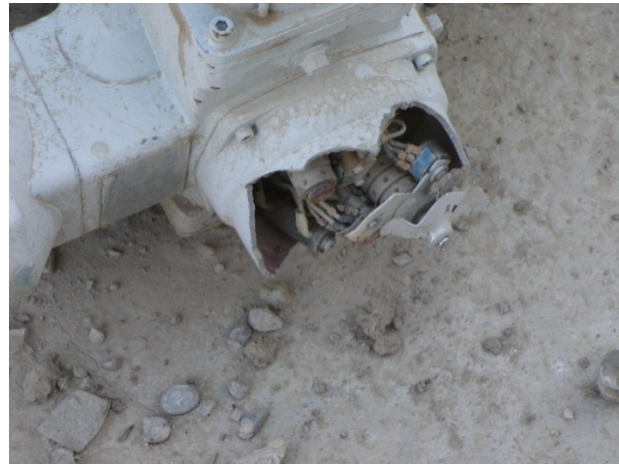
The motor operator on the motor operated bypass valve and a hand-wheel operated guard valve on the inlet valve by-pass have been damaged and will require replacement. The manual valve stem is bent and the handwheel is broken as well.

Broken motor operator on the Main Inlet Valve bypass

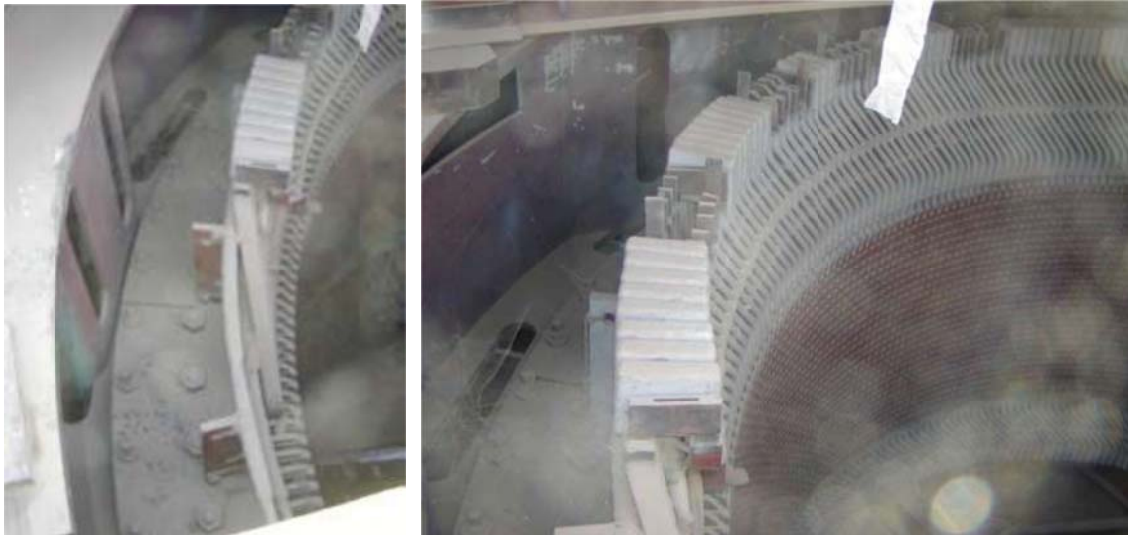
The workmanship of the stator winding installation appeared to be satisfactory and the winding appeared to be properly supported to be able to sustain short circuit forces. The stator slot wedges were found to be excessively loose. This could be due to a combination of installation technique, transportation movement and vibration over sea and land, and a sustained storage period.

Two views of the stator showing heavy contamination of dust, dirt and spider webs

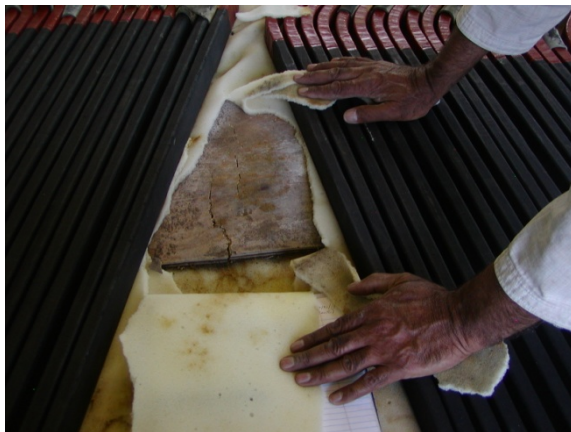
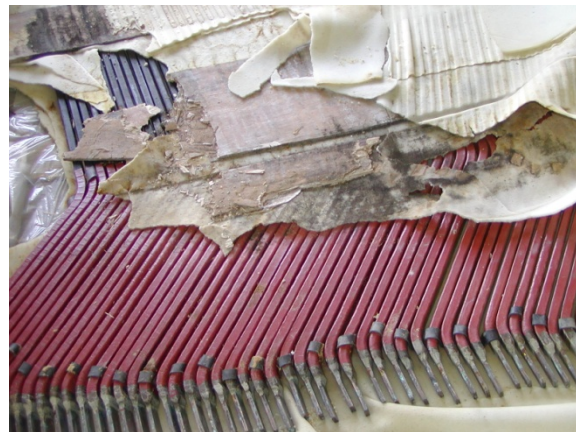
The Stator winding Roebel bars for completing the winding after the two halves of the stator are married were shipped separately in a large crate. Included in the crate are 94 bars for the slot tops and 34 bars for the slot bottoms. The crate had outward evidence of having been exposed to the elements (always left outdoors) by a heavy accumulation of dust, dirt, water stains and rodent waste. The interior of the crate showed evidence of heavy free water intrusion to the extent that the plywood separators between top and bottom layers of bars were completely dry rotted and the sponge packing material was heavily stained and mildewed. The mildewed packing had adhered to the bar surface, including the slot sections. Some of the bars were sounded (tapped) and some produced a hollow sound instead of producing a sharp ring. Because the bars have been exposed to extended periods of dampness and they exhibited delamination when sounded, they will not provide a full service life of operation. Because of the condition of these bars KHPP has assumed to replace all 94 top bars and 34 bottom bars.

**Conditions inside the crate housing the stator bars for the open slots. Water damage, mildew, dry rot and rodent waste.**

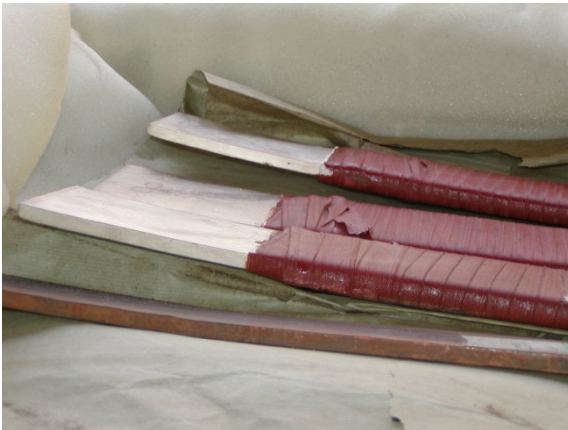
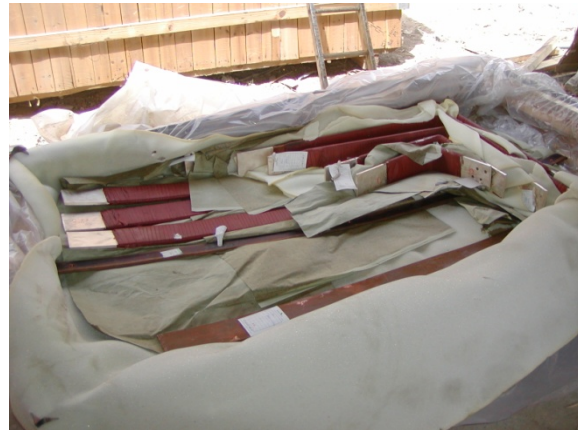
The generator bus leads were found to be badly bent in bowed condition due to a crushed and deformed crate. The bus sections will need to be straightened before installation and then bench tested. If the leads fail hi-pot testing, they will have to be hand re-insulated on site. This can easily be done since personnel and insulating materials will already be on site for the normal erection process.

**Main generator bus leads found bent (bowed) in the shipping crate.**

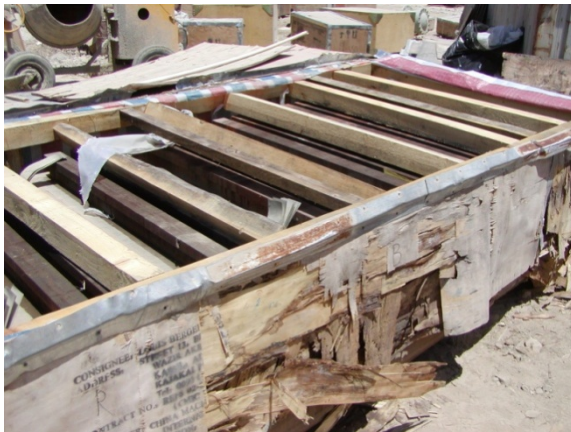
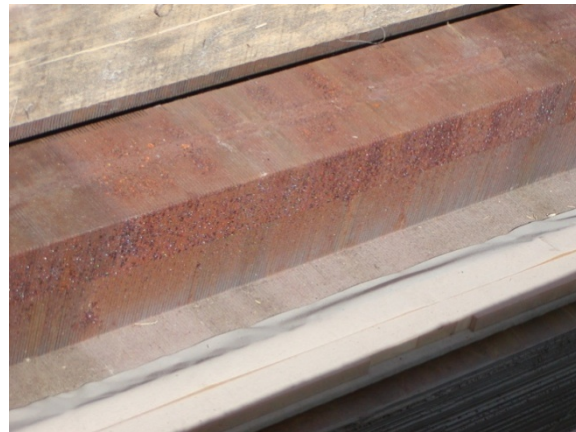
Field poles were found in crates in the Laydown Yard. The roof of one crate was severely deteriorated and the side of another crate appears to have been damaged. The pole assemblies included steel poles that were rusted and heavily contaminated with dust and dirt. The inner field pole collars (washers) were sitting loose on winding with the first turn of the winding loose. It is not known if the rust or deterioration has damaged the groundwall insulation. At the time of erection these poles will be dissassembled and thoroughly cleaned to ensure that rust or deterioration has not damaged the groundwall insulation.

**Badly deteriorated crate housing generator field poles. Cover was dilapidated and allowed water intrusion which rusted the pole bodies. The insulation on these poles cannot tolerate moisture contamination.**

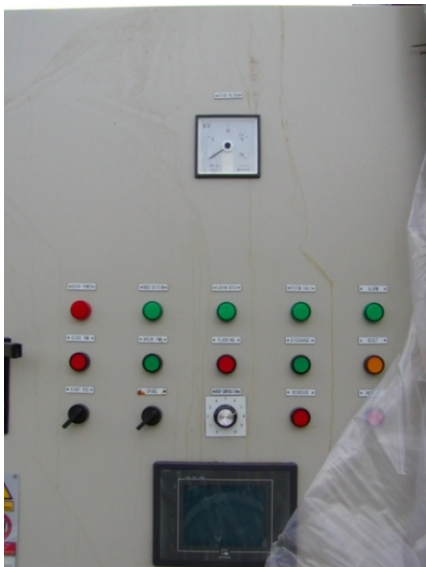
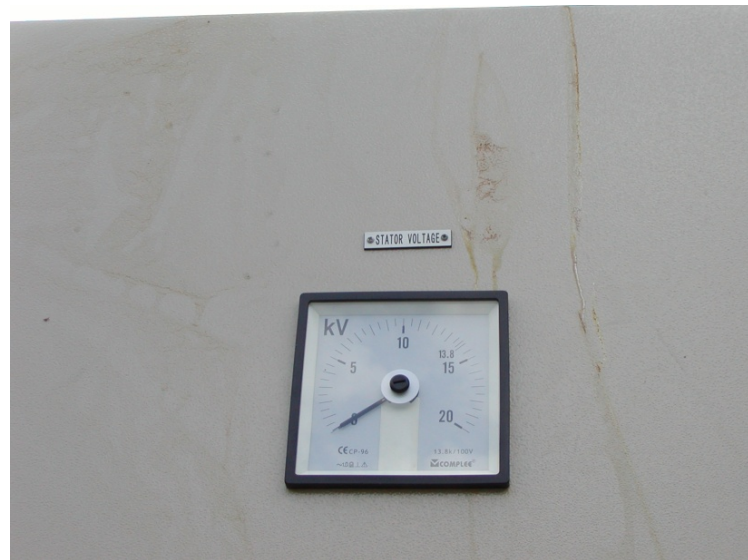
There was evidence of water intrusion into one crate and onto the panel door although the water did not appear to have entered the cabinet interior.

Water stains on exterior of excitation cabinet.

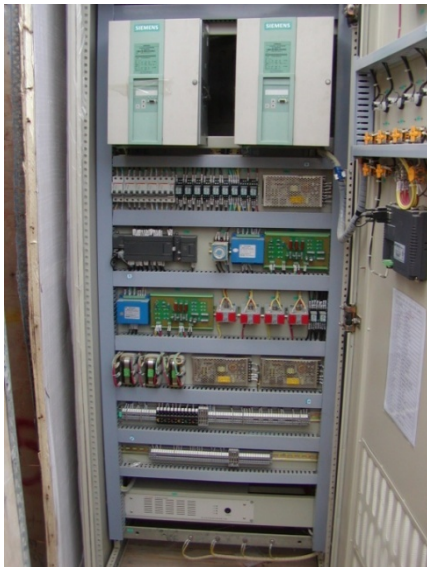
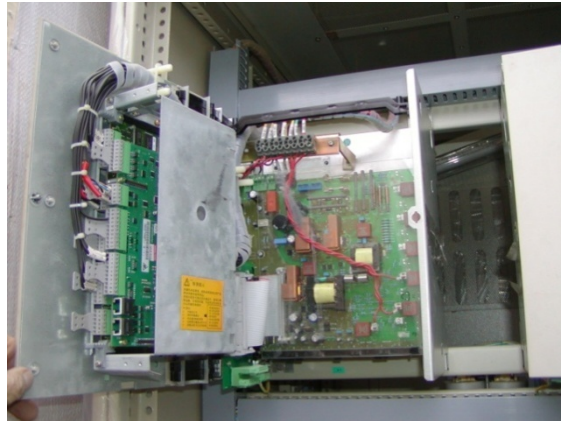
Interior of cabinet is in good condition. No water intrusion and no physical damage. Light dust on all interior components.

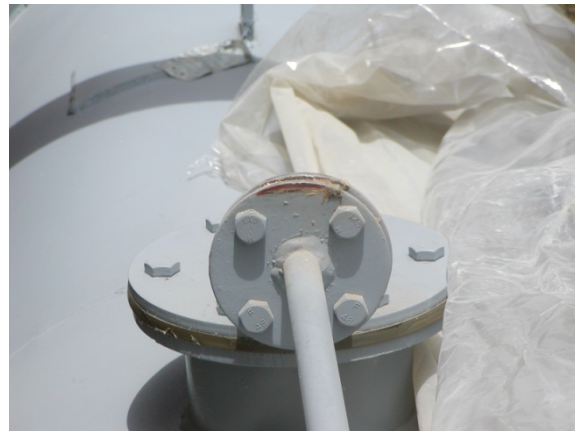
The only damage to any of these components was some minor paint damage to the radiators due to rubbing during shipment, slight paint rub on all conservator vent pipe flanges, and one CT's vent pipe slightly bent.

Slight paint damage to conservator tank vent line flange.

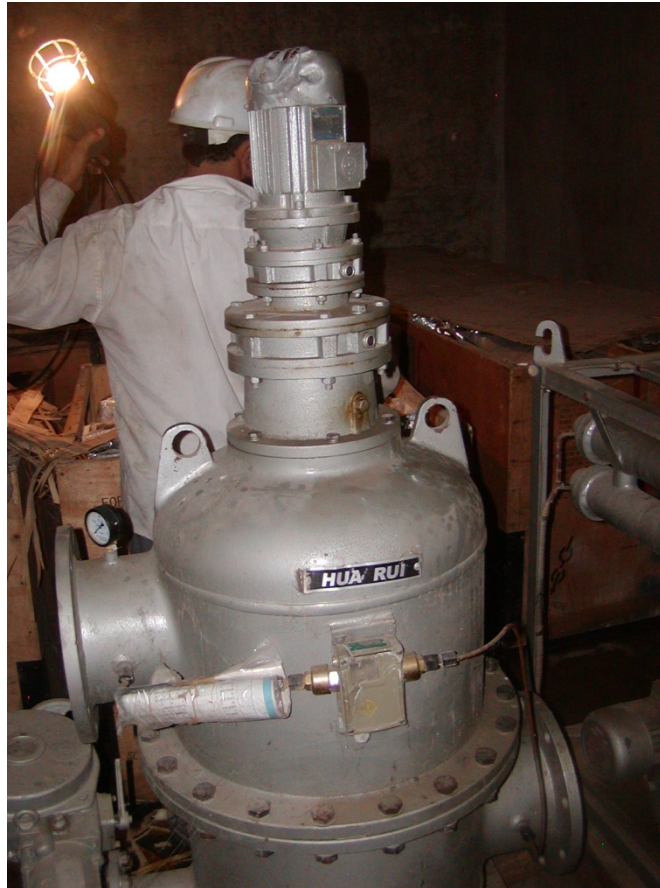
There are two electric motor-driven and differential pressure controlled automatic strainers. These units were reportedly damaged when they fell from a truck while being unloaded by hand. The strainer drive motors were crushed, the differential sensor was broken and the automatic dirty water drain controller was broken. These items will need to be replaced due to their unusable condition.

Self-cleaning strainer with damaged drive motor and differential pressure controller.

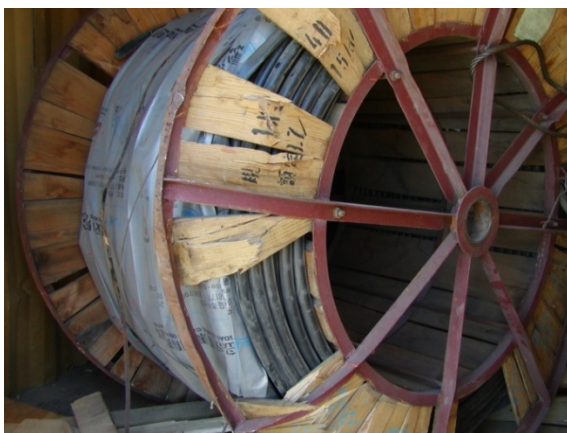
There are 13 reels of electrical cabling in the GFE inventory. The origin tag indicates the type and length of cable on the reels, but no designation as to its intended use. The inventory list shows two additional “rolls” of cable both with the designation DL TJ3, but they have not been accounted for. Some examples are shown below. Some of the cable reels were damaged in shipment but the cable appears to be in serviceable condition.

Cable reel is damaged but condition of cable is uncertain.

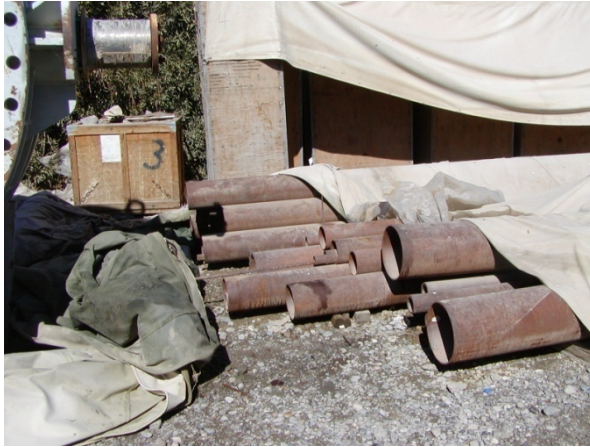
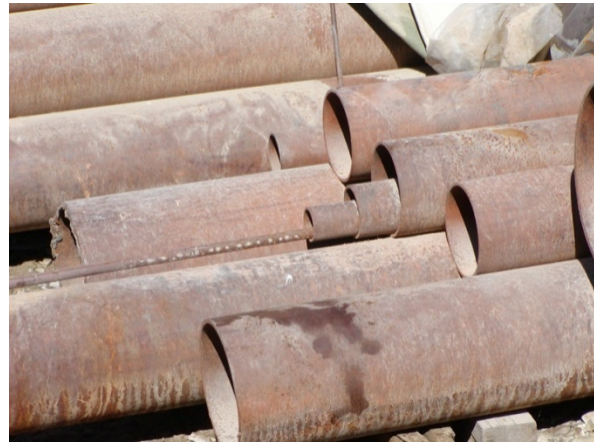
Piping of varying sizes, types and amounts were stored "at large" in the lay down area. The piping is rusty, but otherwise in satisfactory condition. There is no identification on the piping and the GFE Inventory List is vague as to description and amount. The piping is for the air, cooling water or lube oil systems.

Loose piping in Laydown Area. Material is rusty but undamaged. No labeling or marking present.

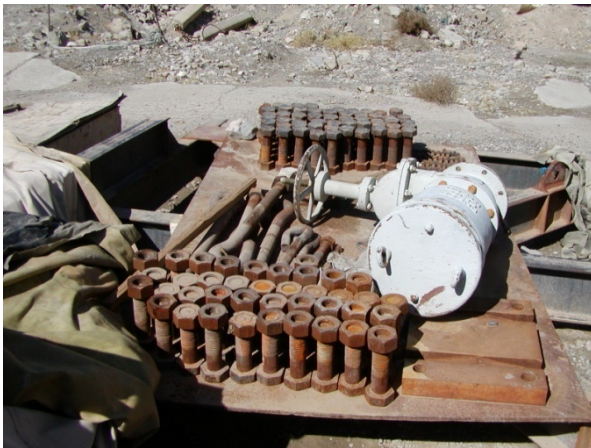
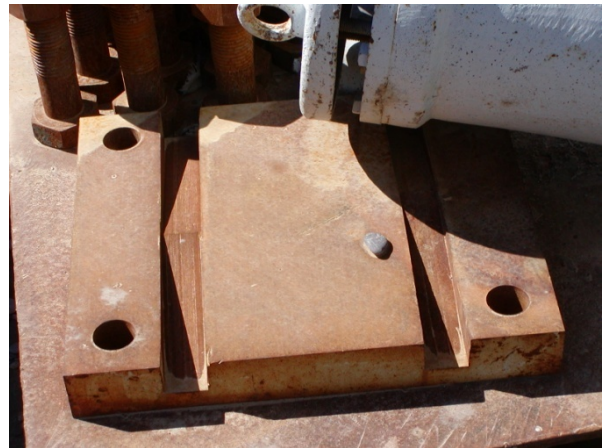
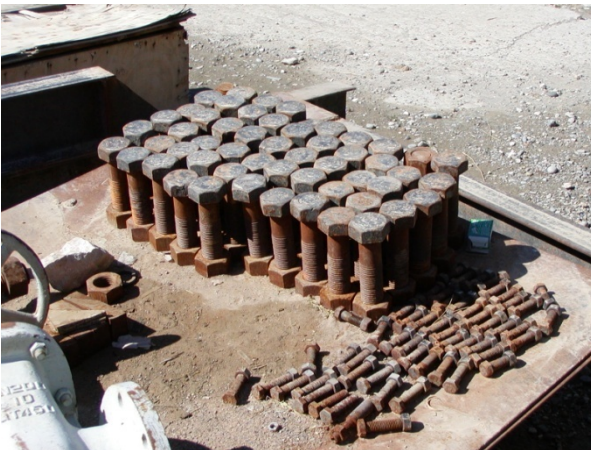
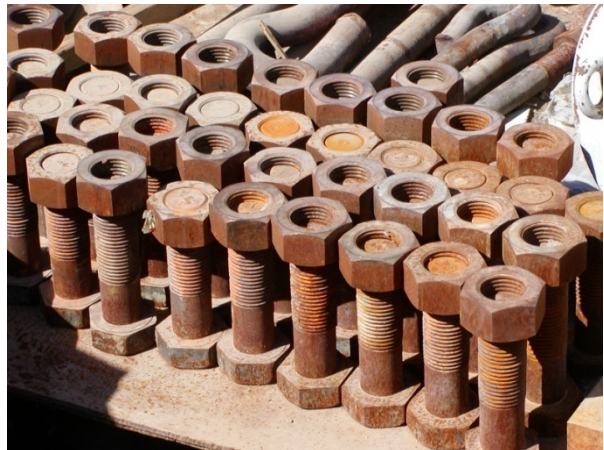
A quantity of nuts and bolts and other hardware were found stored loose with no crate or markings of any kind. The bolts are of steel and are heavily rusted. It could not be determined from visual examination whether they are corroded beyond use or just have superficial rust. Their suitability for use will depend on the extent of the corrosion and their intended use.

Nuts and bolts and a sole plate stored openly without crating or any documentation.

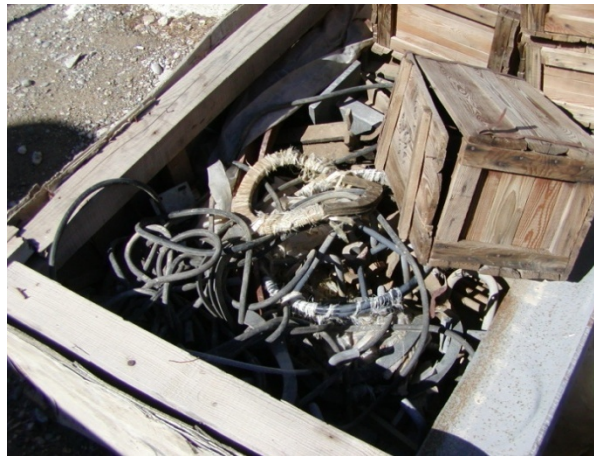
A quantity of rubber type O-ring and flat gasket material was located in a wooden crate with no top, exposing the material to the elements. This material has become weather-beaten as evidenced by cracking and lack of flexibility. It is obviously not suitable for use and must be replaced.

Rubber O-Ring, shaft seal packing and gasket material exposed to weather and unusable.

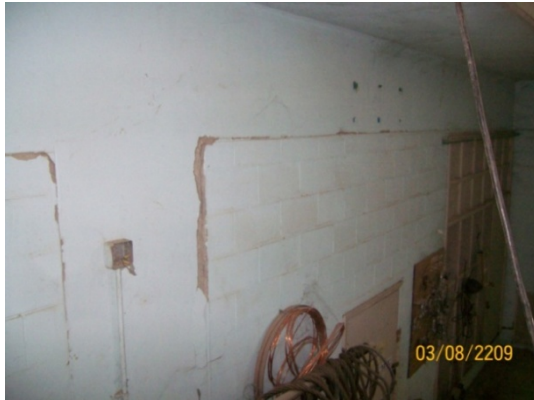
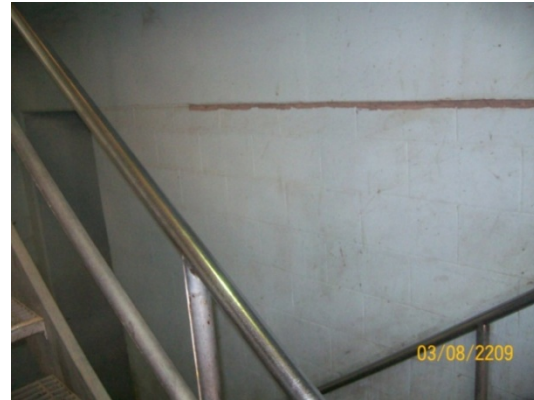
Cracks in the mortar joints of the masonry walls are not structurally significant.

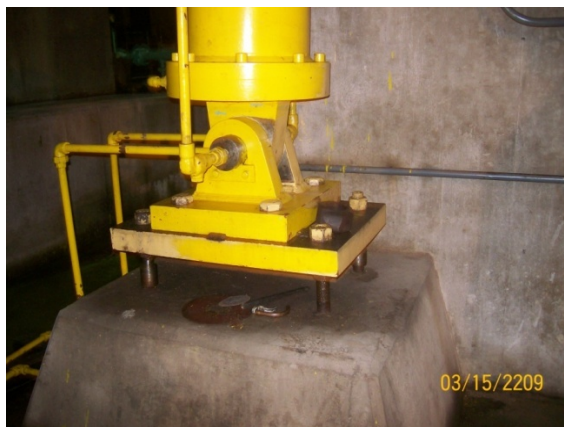
The servo was not grouted after installation. Note the couplers placed on the anchor rods.

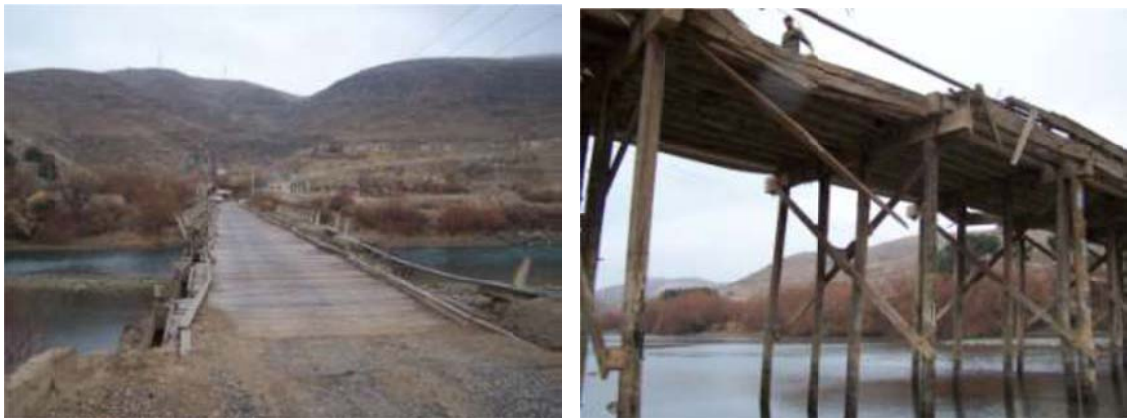
Views of the wooden bridge with a wood drive path. Some of the wooden structure is severely deteriorated.

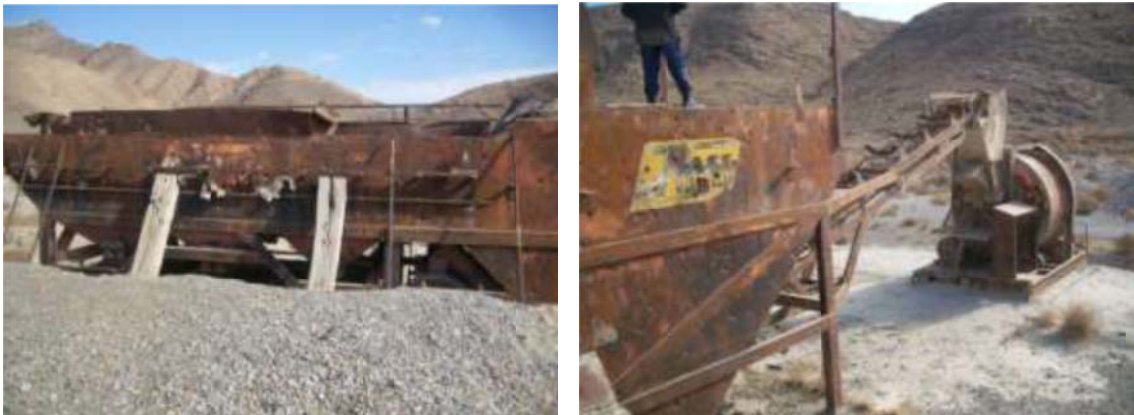
Views showing the condition of the batch plant. The aggregate bin has many holes and is severely rusted.
